LOWER BEECHMONT MURAL PROJECT

SITE 1: CORNER OF FREEMANS ROAD & NORTH ROAD, LOWER BEECHMONT, 4211.

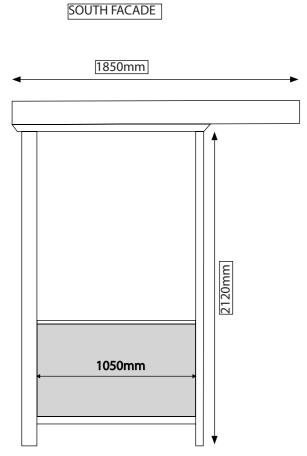
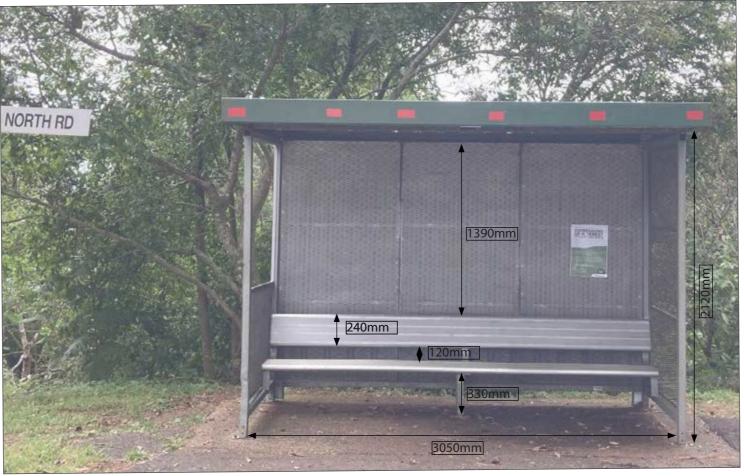
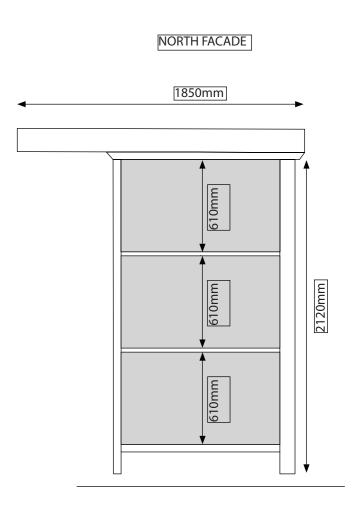
SITE 1: CORNER OF FREEMANS ROAD & NORTH ROAD, LOWER BEECHMONT, 4211.

- Steel frame
- Aluminium bench seat
- · Steel perforated mesh screens on sides

- Steel perforated mesh on the back
- Concrete Slab on the ground
- · Corrugated roof

- Meeting place at the top of Beechmont Road and the start of Freemans Rd (left) and North Rd (right)
- Clear and maintain gutter and drain
- Clean shelter and slab with high pressure
- Frame and screen are in good condition
- Roof and fascia in good condition
- Sloped bush at the back on the bus stop (not seen from the road)

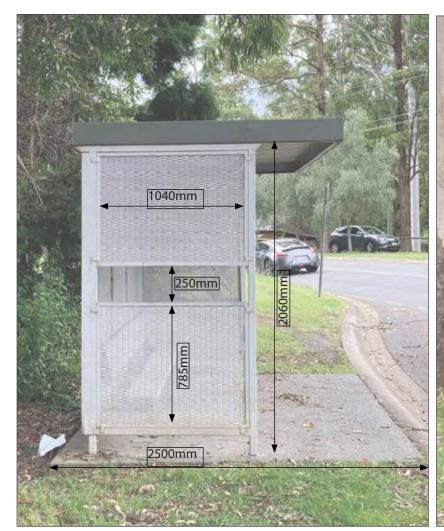
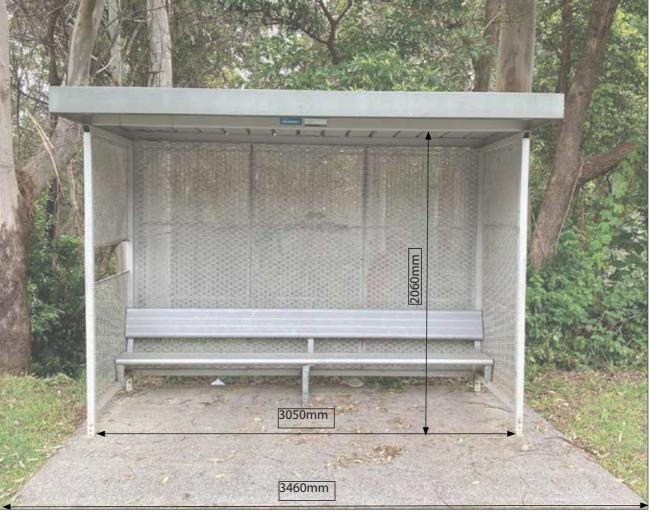
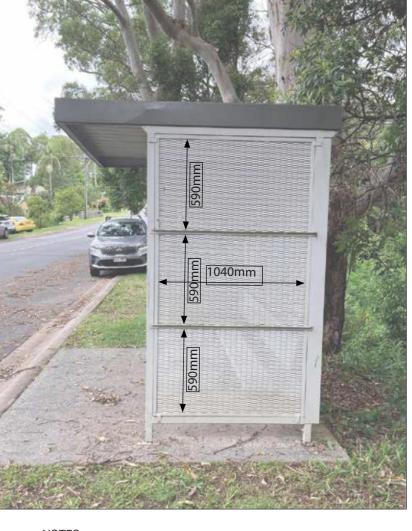
NORTH FACADE SOUTH FACADE EAST FACADE

- Steel frame
- Aluminum bench seat
- Steel perforated mesh screens on sides and rear
- Corrugated roof
- Steel fascia
- Concrete Slab on the ground

- Sloped bushland behind bus stop (rear facade not visible from the road).
- Clear and maintain gutter and drain
- Clean shelter and slab with high pressure
- Frame and screen are in good condition
- View of the shelter from North is partially blocked by a large gum tree

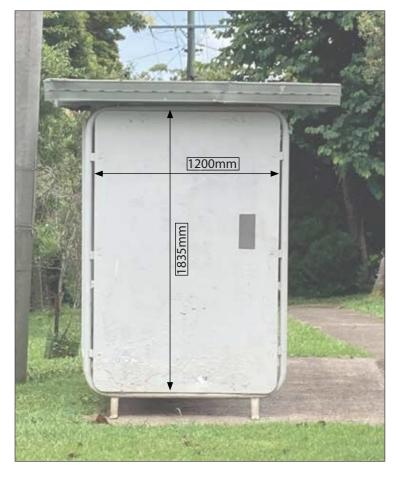
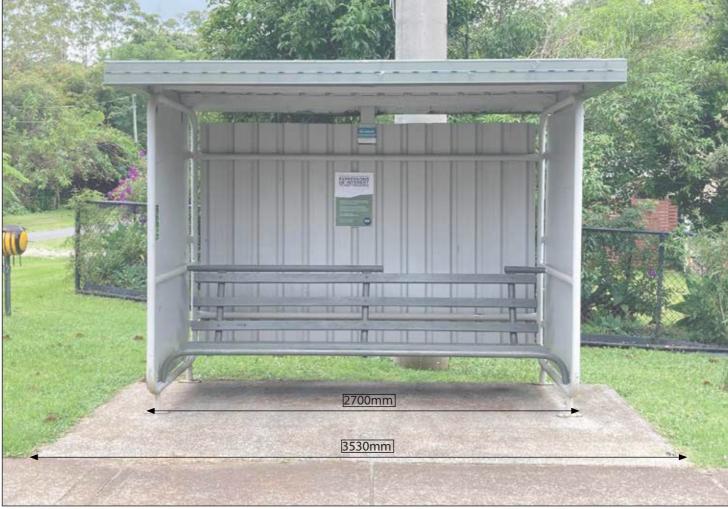
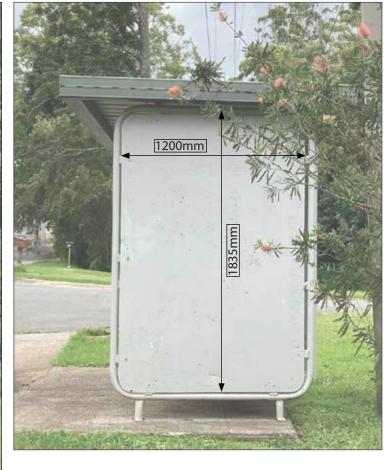
- Steel frame
- Steel sheet sides with rounded edges.
- · Corrugated rear
- Corrugated roof and gutter
- Timber slat bench
- · Concrete Slab on the ground

- · Steel sheets have layers of paint that is textured
- Clear and maintain gutter and drain
- Clean shelter and slab with high pressure
- Frame and screen are in good condition
- View of the shelter from North is partially blocked by a large gum tree

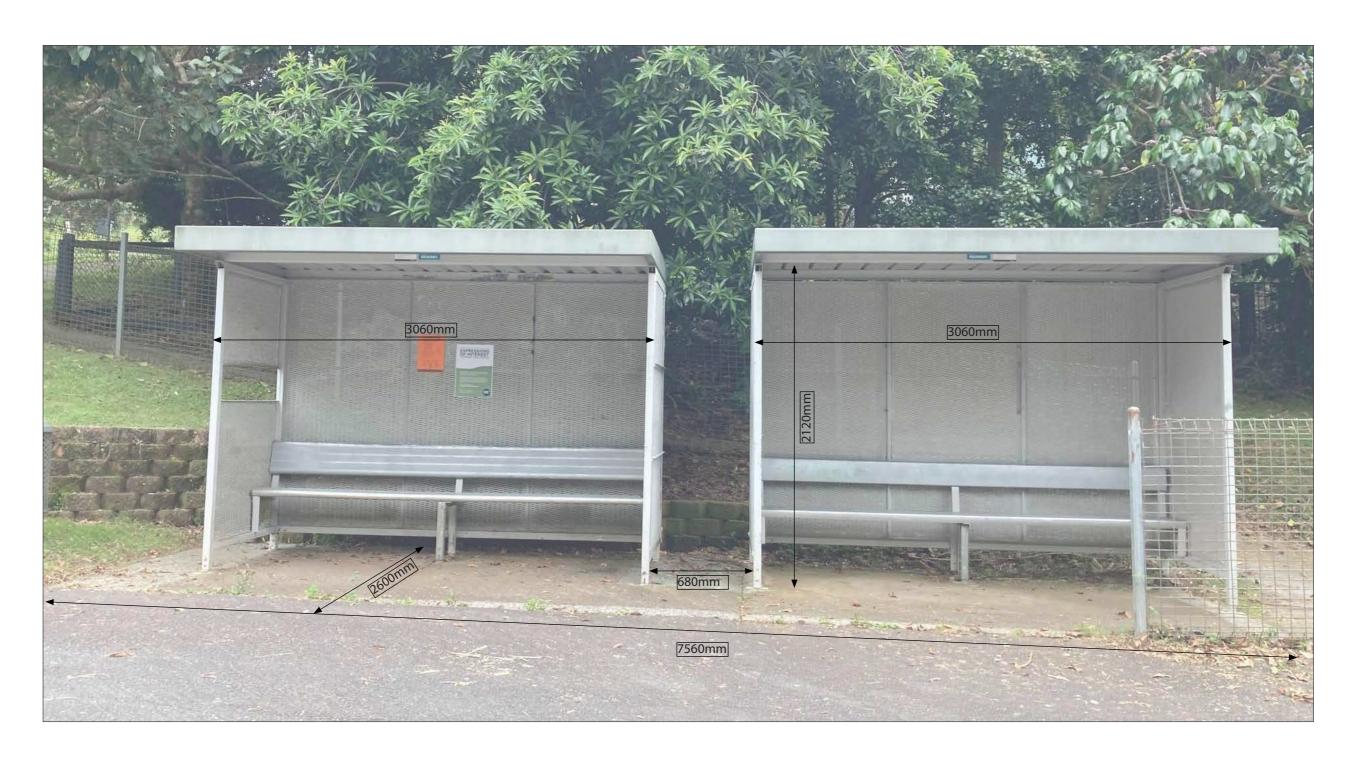
SITE 4: CORNER OF NORTH ROAD & BEECHMONT ROAD, LOWER BEECHMONT, 4211.

- Double bus stops on large slag
- Steel frame
- Aluminum bench seat
- Steel perforated mesh screens on sides and rear
- Corrugated roof
- Steel fascia
- Concrete Slab on the ground

- Walkway at the rear
- Busy road
- Clear and maintain gutter and drain
- Clean shelter and slab with high pressure
- Frame and screen are in good condition
